# WATER OPERATION AND MAINTENANCE BULLETIN

No. 194

December 2000

- Dam Drain Cleaning – Successes and Failures
- Fence Crossings at Canals
- Bollard Installation at Sims Pond Dam
- Radial Gate, Held in Place Without Bolts for 14 Years, Finally Fails

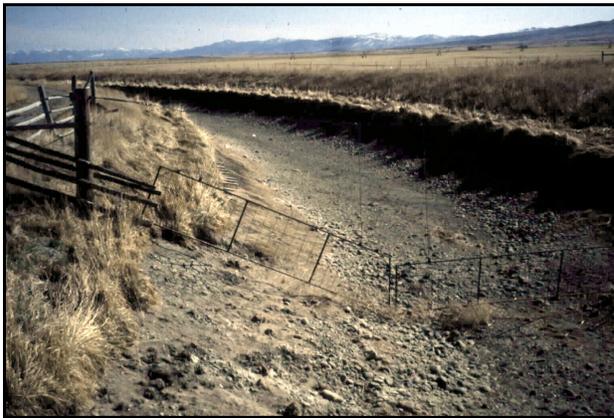
*Photo 1*

Photo 1 shows the gates in the lowered position (dry canal). In this position, the gates are held upright in place by a permanent post and cable suspension system, built with 3/8-inch diameter cable. This suspension system is visible in photo 2. There is a horizontal suspension cable with vertical cables reaching to the two top corners of each gate. Chains (with an appropriate amount of slack) can be used to link the gates on the side or at the bottom.

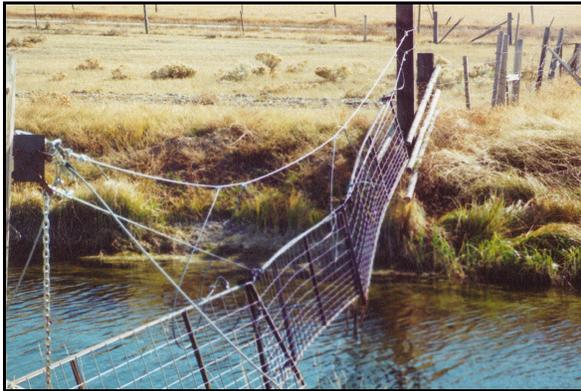
*Photo 3*

A second horizontal cable line is strung through eyelets at the two top corners of the middle gate (photos 3 and 4). One end of this cable is firmly attached to the mounting post on one side of the canal. On the other side of the canal, the cable can be tightened or loosened with a winch or pickup truck to raise or lower the gates. The cable slides freely through the gate eyelets as it is tightened or loosened.

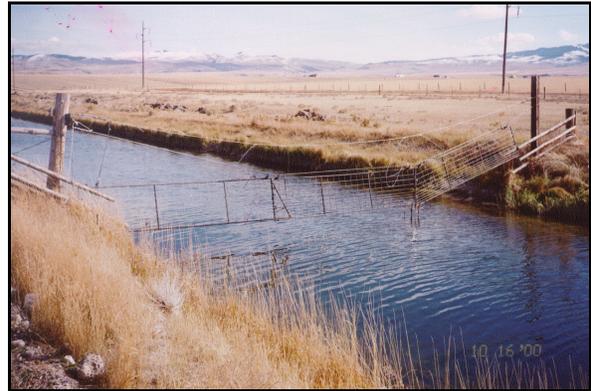
*Photo 4*

In the raised position (photo 4), the cable can be locked in place (photo 5) during the irrigation season. Raising or lowering the gates takes about 10 minutes.

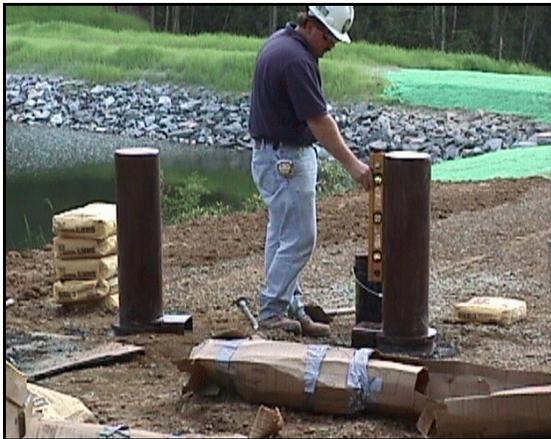
*Photo 1*

To ensure that visitors on the heavily used Parkway would not fall down the access road and onto the dam crest in their vehicles, two bollards were placed at the start of the access road (see photos 1-3 and drawings 1 and 2).

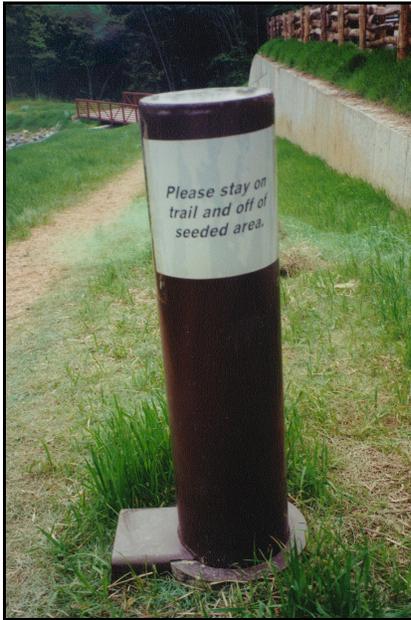
*Photo 2*

The bollards satisfied the design objectives. They are rugged and should provide significant resistance to unauthorized vehicular access. The removable posts are heavy enough that a

dedicated effort is required to remove the posts, even when not padlocked. NPS personnel selected the finish color for the bollards to match other Parkway facilities. Pedestrians pass unobstructed between the bollards on the hiking trail.

Were the bollards to be designed today, lifting handles would be added to the removable posts. The handles would be attached solidly enough for safe lifting but not be attached firmly enough to provide an attachment point for attempted unauthorized removal. Also, the lock would be raised slightly to provide easier authorized access to the padlock yet retain the lock protection and ease of access over the embedded anchor pipes.
